# Road Inventory and Condition Assessment of Paved Routes Walnut Canyon National Monument

**Federal Lands Highway  
Road Inventory Program**

**Federal Highway Administration  
Eastern Federal Lands Highway Division  
Road Inventory Program (RIP)**

**Report Date: December 2016**

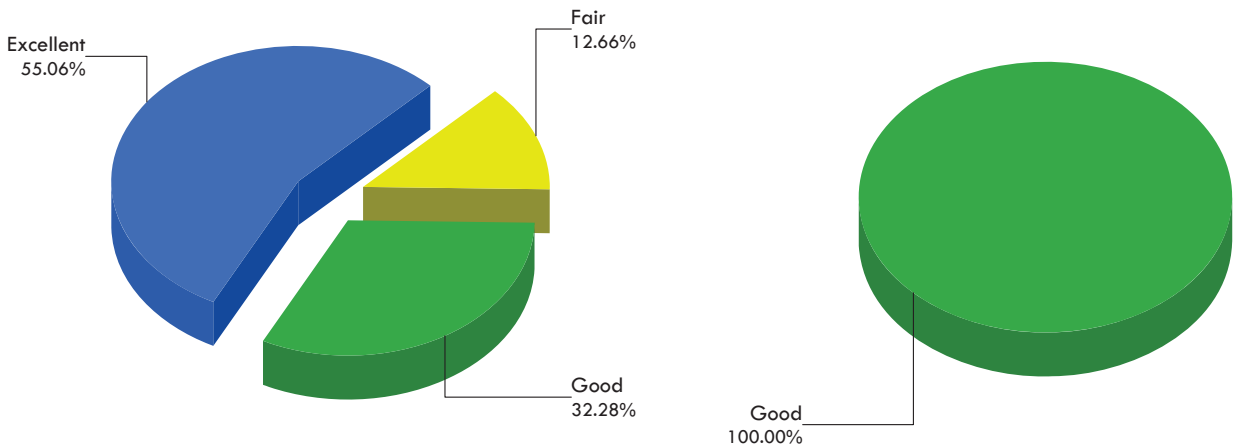
Figure 1: Pavement Condition Rating Breakdown for Paved Roads and Parking Areas

**Road Condition Percentages**

**Parking Area Condition Percentages**

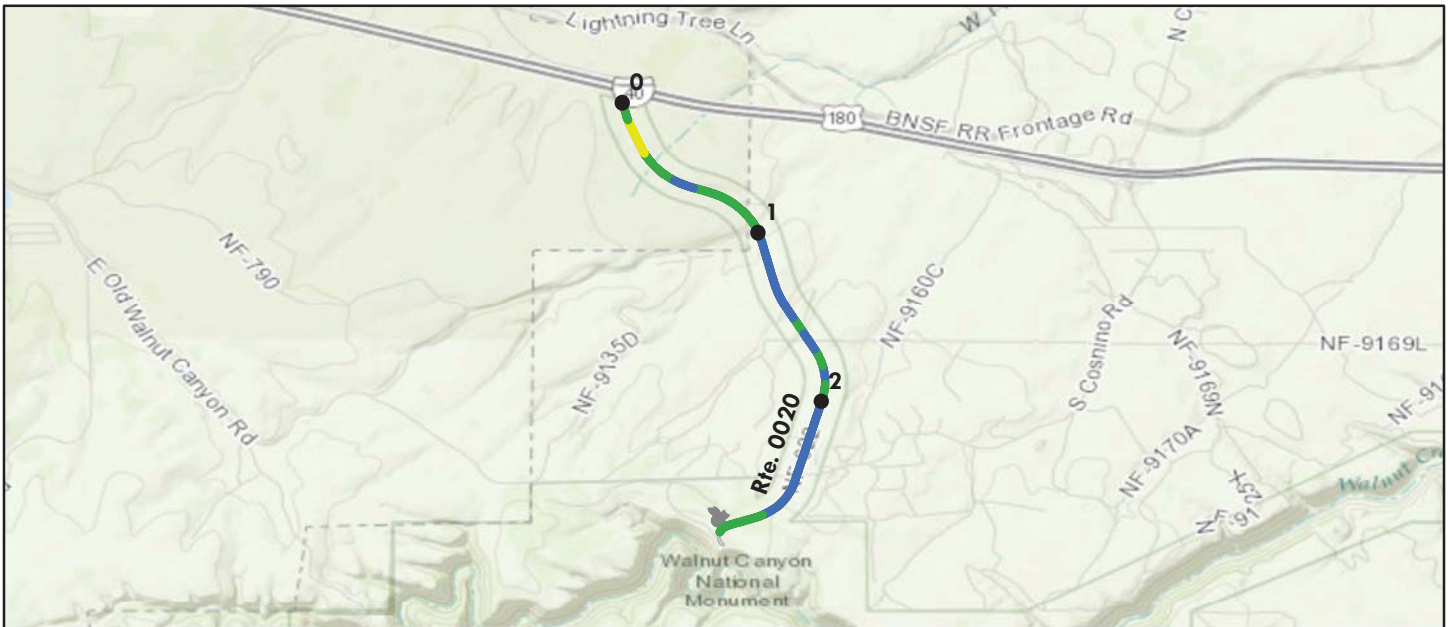
## ROUTE 0020: WALNUT CANYON ENTRANCE ROAD

Route Condition Legend – Pavement Condition Rating (PCR)									
Poor (0 - 60)		Fair (61- 84)		Good (85 - 94)		Excellent (95 - 100)		Not Rated	
See Appendix for definitions and formulas									
<b>Inspection Date:</b>	7/12/2016	<b>Beginning Section MP</b>	0	1	2				
<b>Paved Length (Miles):</b>	2.93	<b>Section Length (MI)</b>	1	1	0.93				
<b>Surface Type:</b>	ASPHALT	<b>Route Summary</b>							
<b>Roadway Condition Information</b>									
Pavement Condition Rating (PCR)	94	88	97	96					
Surface Condition Rating (SCR)	93	91	95	94					
Roughness Condition Index (RCI)	95	84	100	100					
<b>Distress Index Values</b>									
Structural Crack Index	98	94	99	100					
Alligator Crack Index	100	100	100	100					
Longitudinal Crack Index	98	94	99	100					
Transverse Cracking Index	93	91	95	94					
Patching Index	100	100	100	100					
Rutting Index	99	99	100	100					
International Roughness Index (IRI)	128	158	115	108

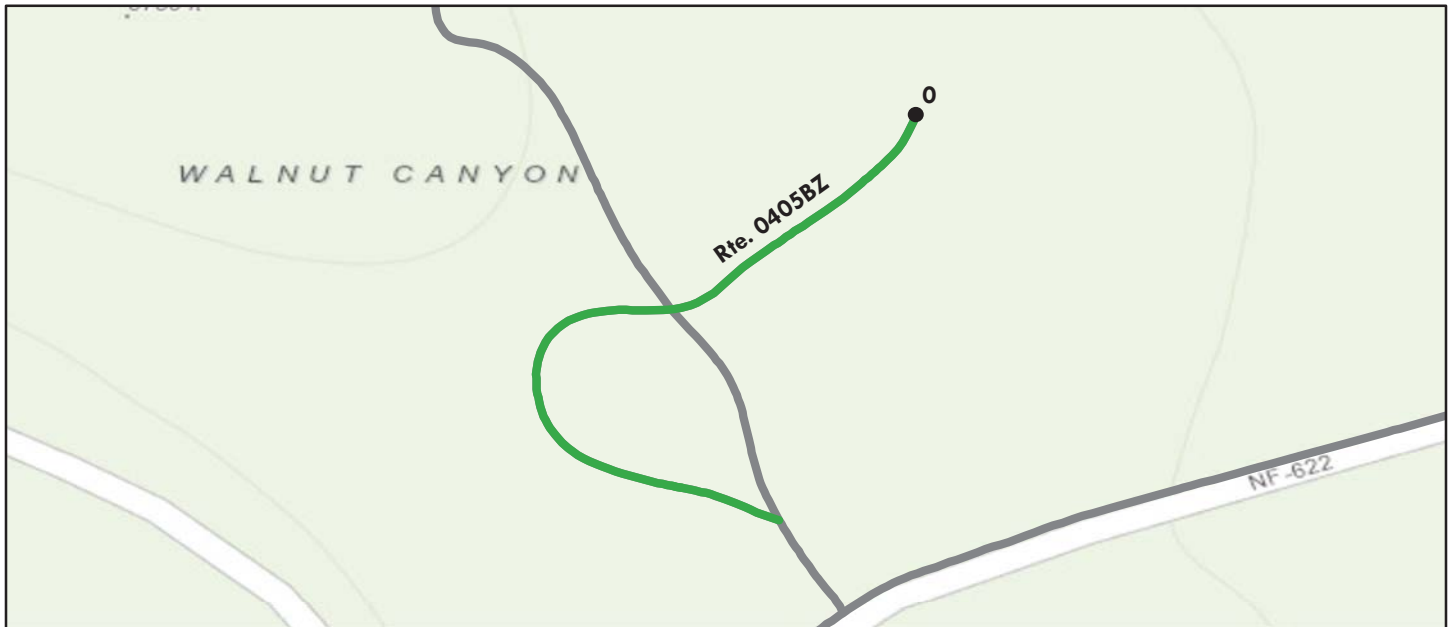
Subcomponent of Route WACA-0405ZZ

Route Condition Legend – Pavement Condition Rating (PCR)						
Poor (0 - 60)	Fair (61- 84)	Good (85 - 94)	Excellent (95 - 100)	Not Rated		
See Appendix for definitions and formulas						
<b>Inspection Date:</b> 7/12/2016	<b>Beginning Section MP</b>	0				
<b>Paved Length (Miles):</b> 0.11	<b>Section Length (MI)</b>	0.11				
<b>Surface Type:</b> ASPHALT	<b>Route Summary</b>					
<b>Roadway Condition Information</b>						
Pavement Condition Rating (PCR)	85	85				
Surface Condition Rating (SCR)	85	85				
Roughness Condition Index (RCI)	N/A	N/A				
<b>Distress Index Values</b>						
Structural Crack Index	87	87				
Alligator Crack Index	100	100				
Longitudinal Crack Index	87	87				
Transverse Cracking Index	85	85				
Patching Index	99	99				
Rutting Index	90	90				
International Roughness Index (IRI)	N/A	N/A				
<b>Lane &amp; Width Information</b>						
Number of Lanes	1	1				
Paved Width (ft)	15.2	15.2				
Lane Width (ft)	15.2	15.2

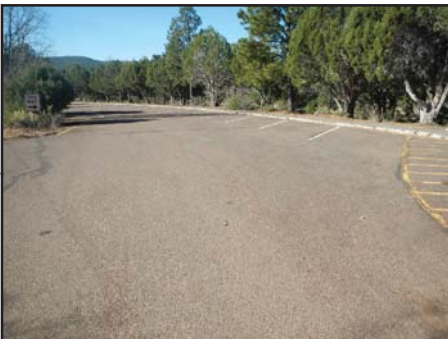
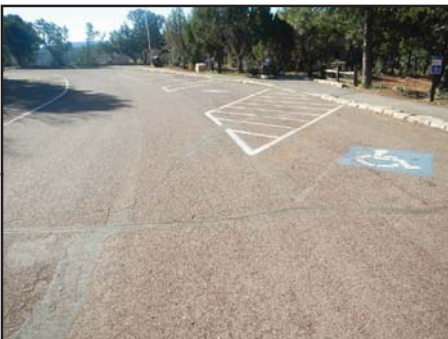
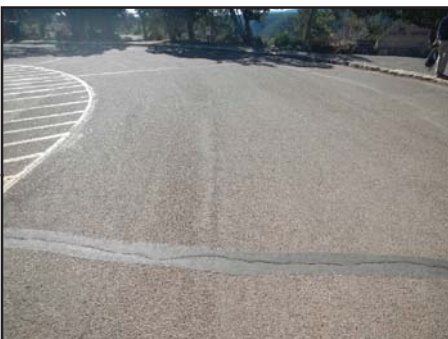
Inspection Date	FMSS Number	User Access	Surface Type
3/24/2016	47349	PUBLIC	ASPHALT
Area (Sq. Ft.)	Lane Miles (11' Widths)	Curb Reveal (Inches)	Curb Recommendation
33,769	0.581	3	NOT APPLICABLE
Curb Type		Curb & Gutter Type	
STONE		NO CURB AND GUTTER	
Pavement Recommendation		Condition Rating / PCR	
PREVENTIVE MAINTENANCE		GOOD / 90

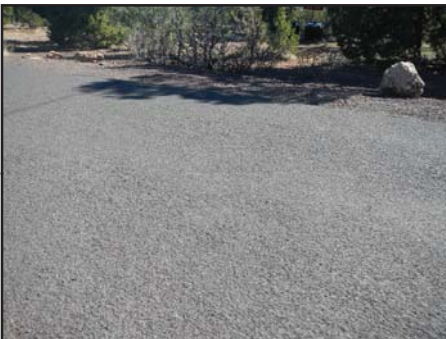
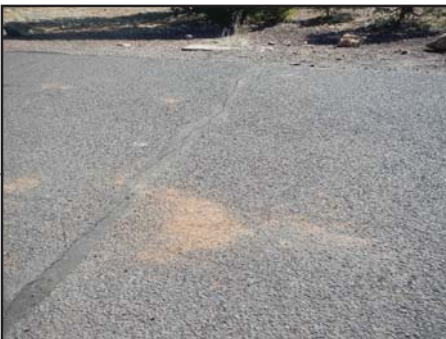
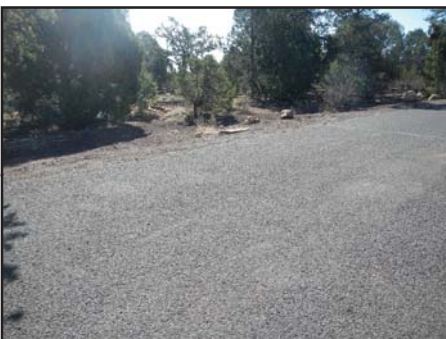
## ROUTE 0919: WALNUT CANYON PICNIC AREA PULLOUT

Inspection Date	FMSS Number	User Access	Surface Type
3/24/2016	228023	PUBLIC	ASPHALT
Area (Sq. Ft.)	Lane Miles (11' Widths)	Curb Reveal (Inches)	Curb Recommendation
1,969	0.034	NOT APPLICABLE	NOT APPLICABLE
Curb Type		Curb & Gutter Type	
NO CURB		NO CURB AND GUTTER	
Pavement Recommendation		Condition Rating / PCR	
PREVENTIVE MAINTENANCE		GOOD / 90
