WACO Cycle 6

Final Report

Road Inventory and Condition Assessment of Paved Routes Waco Mammoth National Monument

Report Date: July 2017

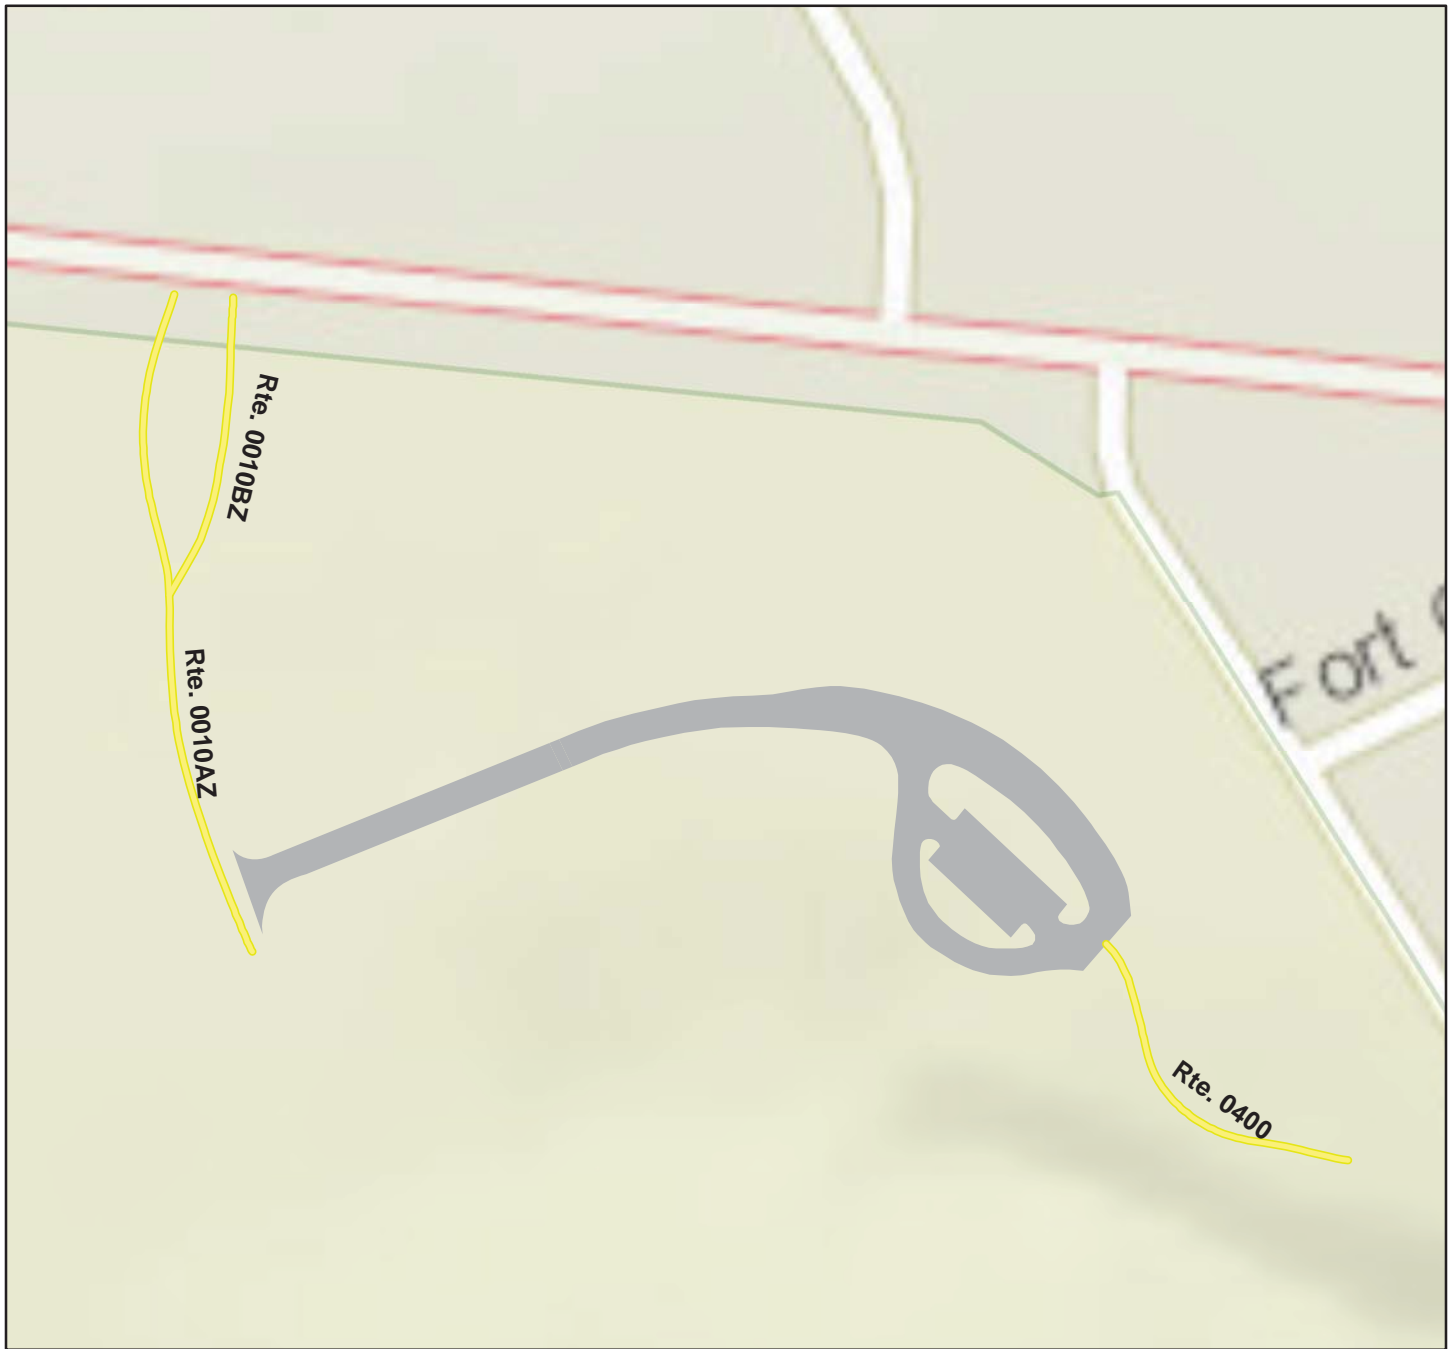
Map 1

PCR - MILE BY MILE

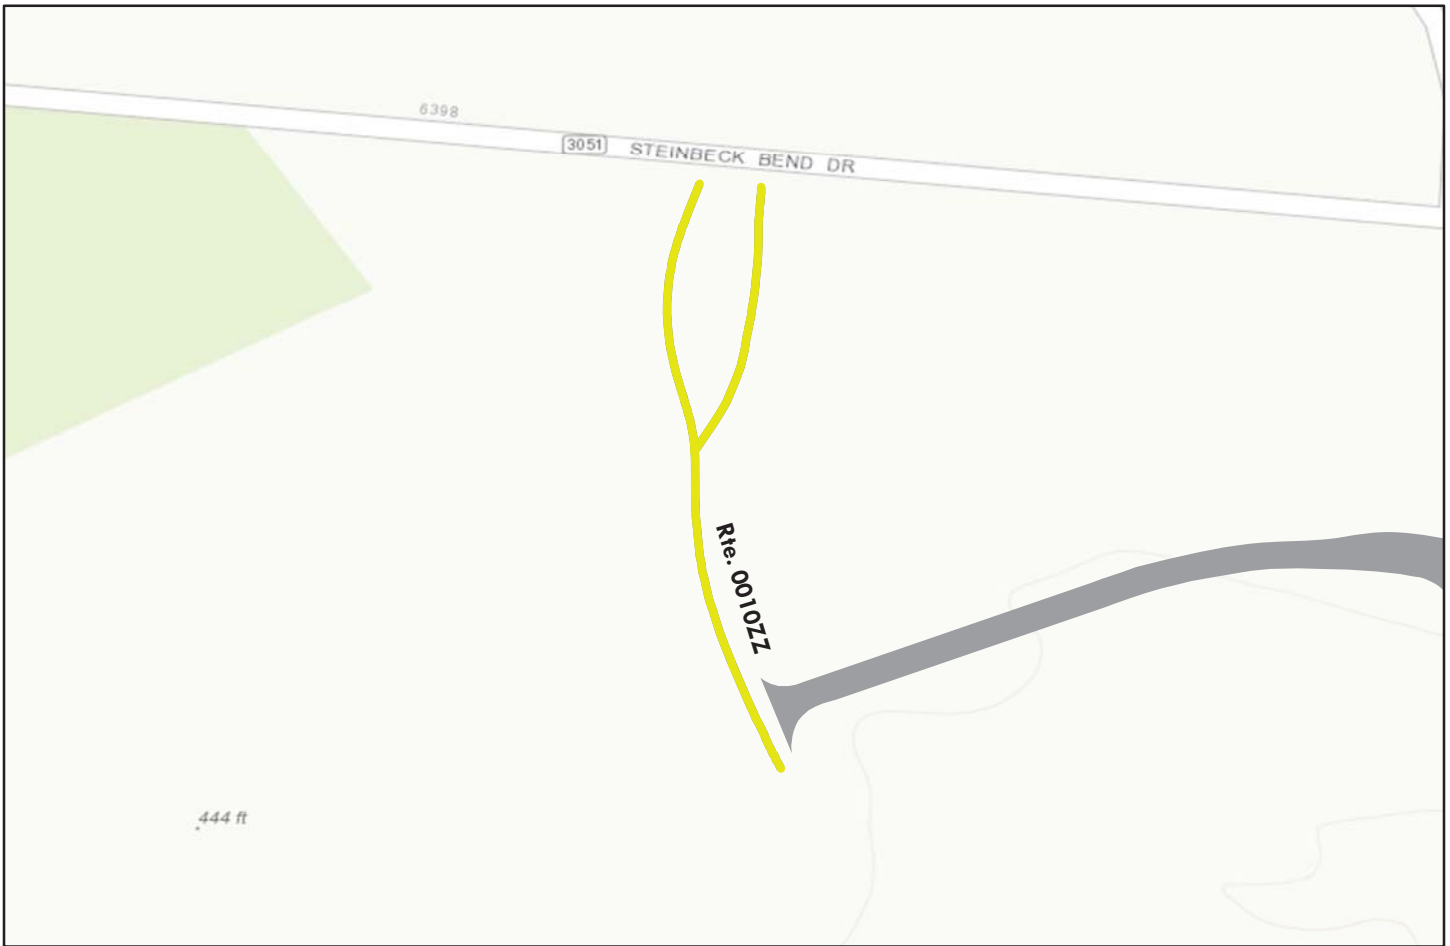
ROUTE 0010ZZ: MAIN ENTRANCE ROADS

Note: The weighted average summary PCR value is calculated from only the sections of road where the PCR was collected. The overall PCR for the summary route may not reflect individual subcomponent ratings.

Route Condition Legend – Pavement Condition Rating (PCR)						
Poor (0 - 60)	Fair (61- 84)	Good (85 - 94)	Excellent (95 - 100)	Not Rated		
See Appendix for definitions and formulas						
Inspection Date: 2/16/2017						
Paved Length (Miles): 0.17						
Surface Type: ASPHALT	Route Summary					
Roadway Condition Information						
Pavement Condition Rating (PCR)	70					
Lane & Width Information						
Number of Lanes	1					
Paved Width (ft)	19.4					
Lane Width (ft)	9.8

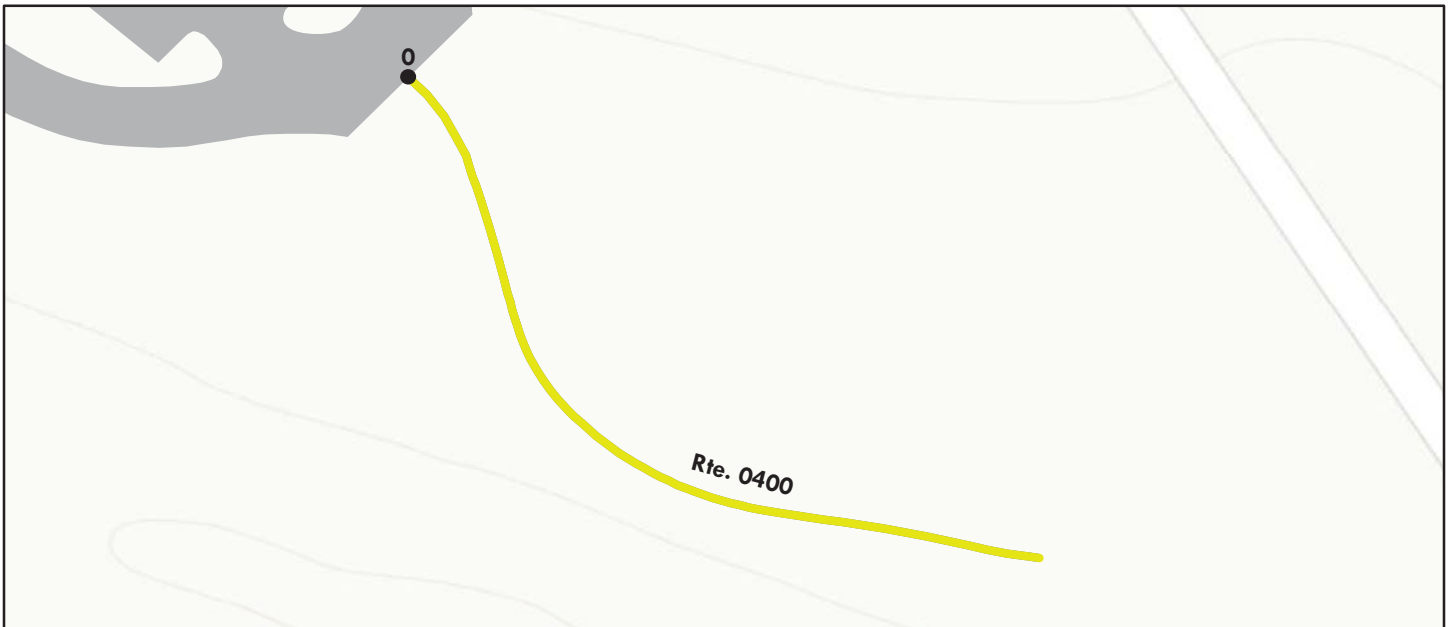
ROUTE 0400: MAINTENANCE ROAD

Route Condition Legend – Pavement Condition Rating (PCR)						
Poor (0 - 60)	Fair (61- 84)	Good (85 - 94)	Excellent (95 - 100)	Not Rated		
See Appendix for definitions and formulas						
Inspection Date: 2/16/2017	Beginning Section MP	0				
Paved Length (Miles): 0.06	Section Length (MI)	0.06				
Surface Type: ASPHALT	Route Summary					
Roadway Condition Information						
Pavement Condition Rating (PCR)	68	68				
Surface Condition Rating (SCR)	68	68				
Roughness Condition Index (RCI)	N/A	N/A				
Distress Index Values						
Structural Crack Index	68	68				
Alligator Crack Index	100	100				
Longitudinal Crack Index	68	68				
Transverse Cracking Index	85	85				
Patching Index	99	99				
Rutting Index	94	94				
International Roughness Index (IRI)	N/A	N/A				
Lane & Width Information						
Number of Lanes	2	2				
Paved Width (ft)	23.2	23.2				
Lane Width (ft)	11.6	11.6

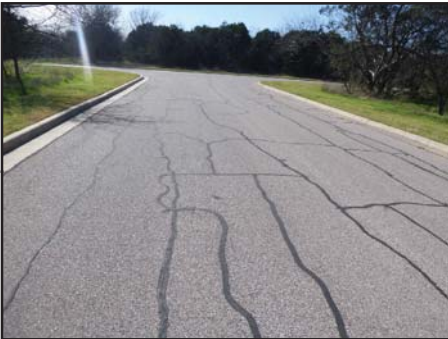
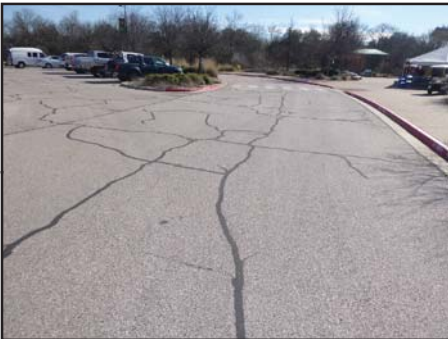
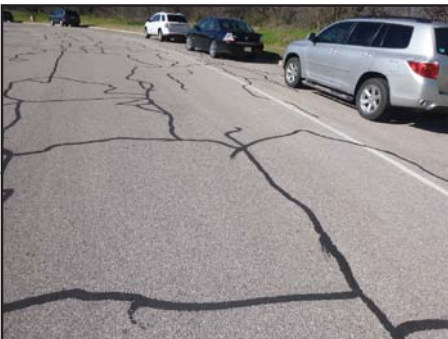
Inspection Date	FMSS Number	User Access	Surface Type
2/16/2017	246303	PUBLIC	ASPHALT
Area (Sq. Ft.)	Lane Miles (11' Widths)	Curb Reveal (Inches)	Curb Recommendation
53,709	0.925	NOT APPLICABLE	LIGHT REPAIR
Curb Type		Curb & Gutter Type	
NO CURB		CONCRETE	
Pavement Recommendation		Condition Rating / PCR	
HEAVY 3R TREATMENTS		POOR / 53

Note: Parking area consists of multiple surface types: 2 parts Asphalt at 53,412 square feet; 1 part Concrete at 297 square feet.
