# WHMI Cycle 6

## Final Report

### Road Inventory and Condition Assessment of Paved Routes Whitman Mission National Historic Site

Report Date: March 2016

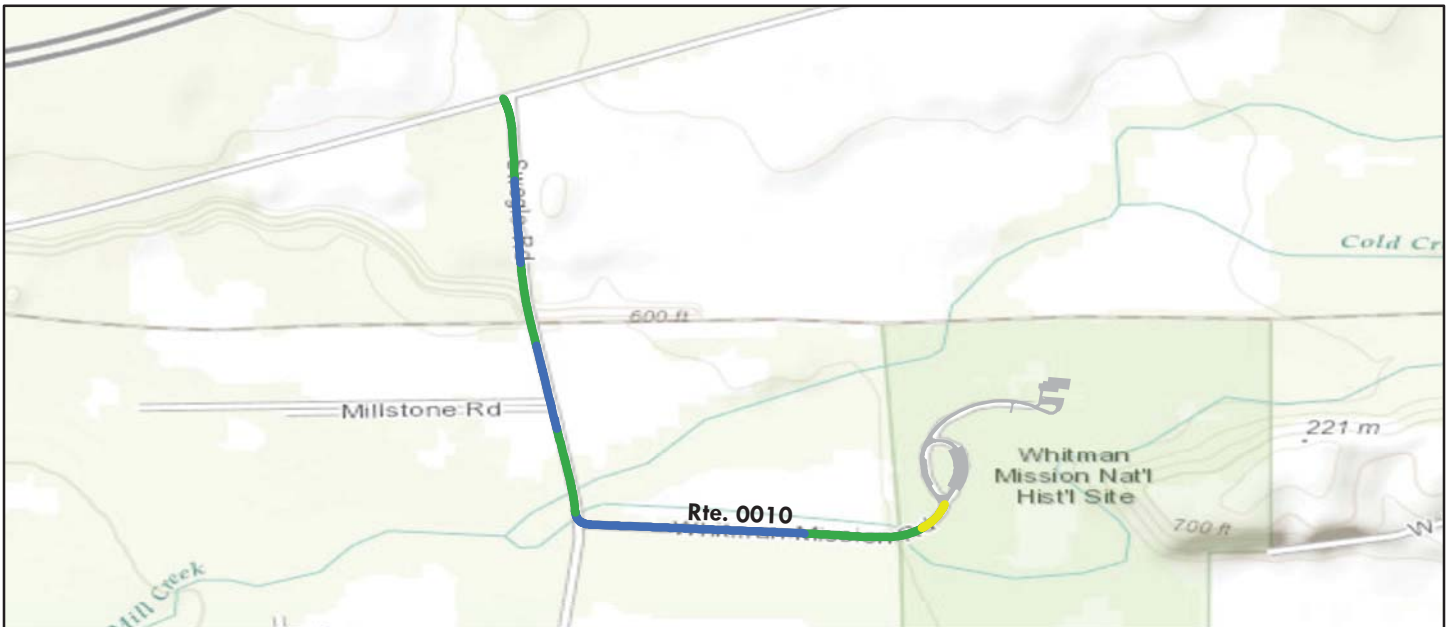
## ROUTE 0010: ENTRANCE ROAD

Route Condition Legend – Pavement Condition Rating (PCR)						
Poor (0 - 60)	Fair (61- 84)	Good (85 - 94)	Excellent (95 - 100)	Not Rated		
See Appendix for definitions and formulas						
<b>Inspection Date:</b>	10/3/2015	<b>Beginning Section MP</b>	0			
<b>Paved Length (Miles):</b>	0.84	<b>Section Length (MI)</b>	0.84			
<b>Surface Type:</b>	ASPHALT	<b>Route Summary</b>				
<b>Roadway Condition Information</b>						
Pavement Condition Rating (PCR)	95	95				
Surface Condition Rating (SCR)	98	98				
Roughness Condition Index (RCI)	90	90				
<b>Distress Index Values</b>						
Structural Crack Index	100	100				
Alligator Crack Index	100	100				
Longitudinal Crack Index	100	100				
Transverse Cracking Index	98	98				
Patching Index	100	100				
Rutting Index	99	99				
International Roughness Index (IRI)	140	140				
<b>Lane &amp; Width Information</b>						
Number of Lanes	2	2				
Paved Width (ft)	26	26				
Lane Width (ft)	11.9	11.9

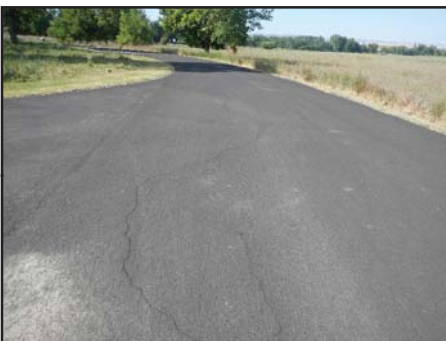
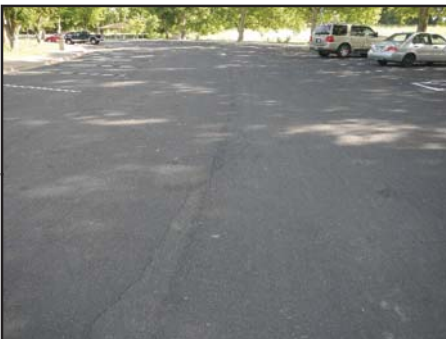
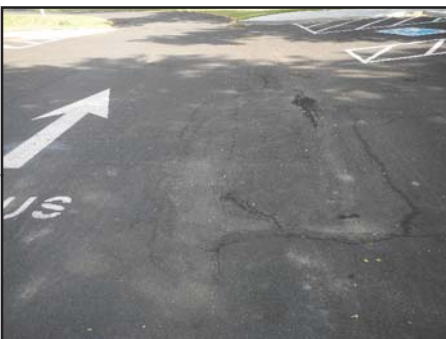
Inspection Date	FMSS Number	User Access	Surface Type
6/23/2015	28276	PUBLIC	ASPHALT
Area (Sq. Ft.)	Lane Miles (11' Widths)	Curb Reveal (Inches)	Curb Recommendation
34,364	0.592	NOT APPLICABLE	DO NOTHING
Curb Type		Curb & Gutter Type	
NO CURB		CONCRETE	
Pavement Recommendation		Condition Rating / PCR	
LIGHT 3R TREATMENTS		FAIR / 73

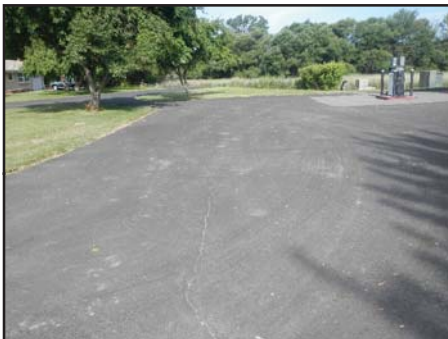
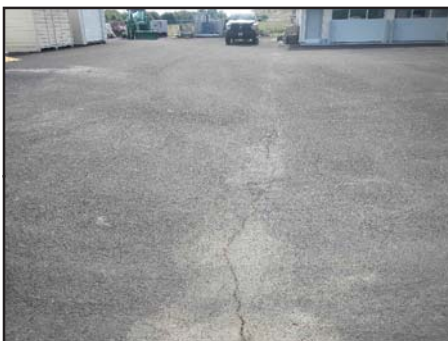
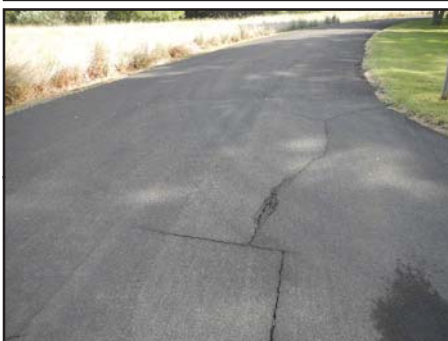
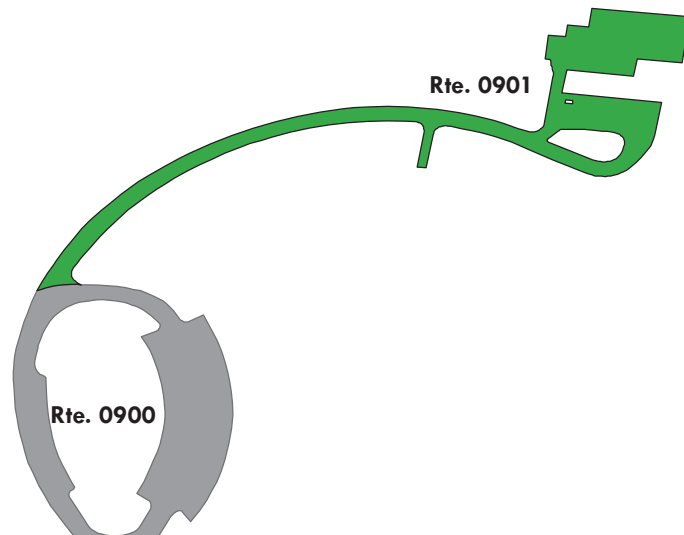
## ROUTE 0901: MAINTENANCE SHOP PARKING AREA

Inspection Date	FMSS Number	User Access	Surface Type
6/23/2015	58415	NONPUBLIC	ASPHALT
Area (Sq. Ft.)	Lane Miles (11' Widths)	Curb Reveal (Inches)	Curb Recommendation
30,706	0.529	NOT APPLICABLE	NOT APPLICABLE
Curb Type		Curb & Gutter Type	
NO CURB		NO CURB AND GUTTER	
Pavement Recommendation		Condition Rating / PCR	
PREVENTIVE MAINTENANCE		GOOD / 90

Parking area consists of multiple surface types: 1 part Asphalt at 30,269 square feet; 1 part Concrete at 437 square feet.
