WIHO Cycle 6

Final Report

Road Inventory and Condition Assessment of Paved Routes William Howard Taft National Historic Site

**Federal Lands Highway
Road Inventory Program**

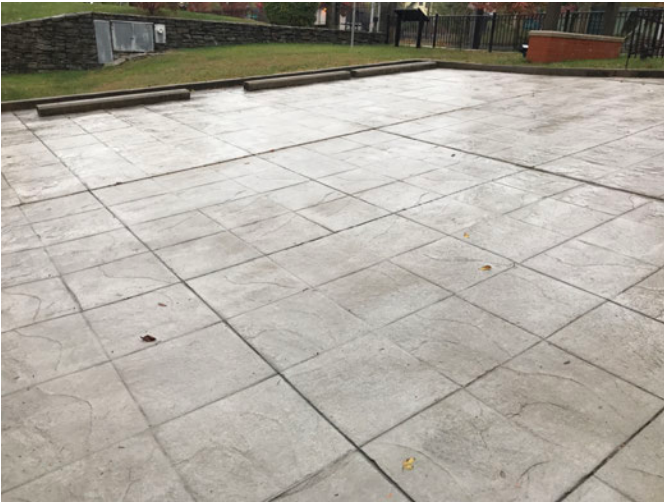
WIHO_0900_4.jpg

Inspection Date	FMSS Number	User Access	Surface Type
10/19/2020	103679	PUBLIC	CONCRETE
Area (Sq. Ft.)	Lane Miles (11' Widths)	Curb Reveal (Inches)	Curb Recommendation
2,532	0.044	6	LIGHT REPAIR
Curb Type		Curb & Gutter Type	
CONCRETE		NO CURB AND GUTTER	
Pavement Recommendation		Condition Rating / PCR	
PREVENTIVE MAINTENANCE		GOOD / 90

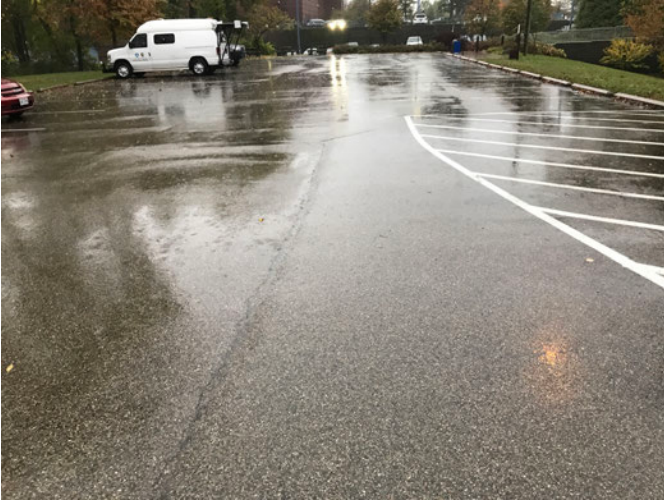
WIHO_0901_4.jpg

Inspection Date	FMSS Number	User Access	Surface Type
10/19/2020	104351	PUBLIC	ASPHALT
Area (Sq. Ft.)	Lane Miles (11' Widths)	Curb Reveal (Inches)	Curb Recommendation
9,655	0.166	NOT APPLICABLE	NOT APPLICABLE
Curb Type		Curb & Gutter Type	
NO CURB		NO CURB AND GUTTER	
Pavement Recommendation		Condition Rating / PCR	
PREVENTIVE MAINTENANCE		GOOD / 90
