WORI Cycle 6

Final Report

Road Inventory and Condition Assessment of Paved Routes Women's Rights National Historical Park

Report Date: December 2020

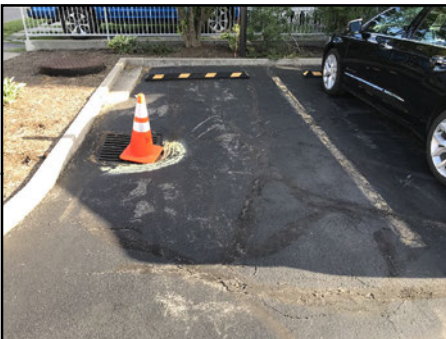
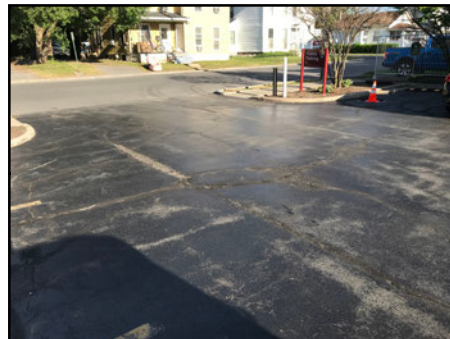
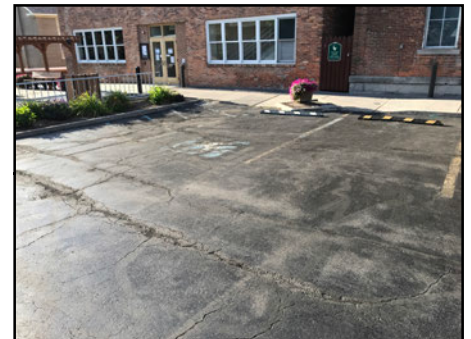
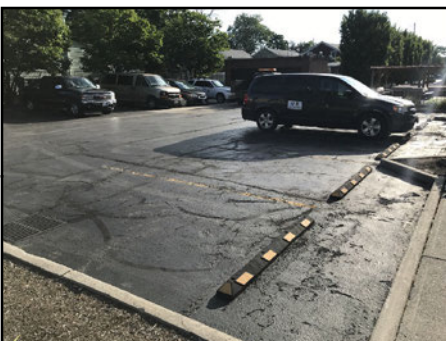
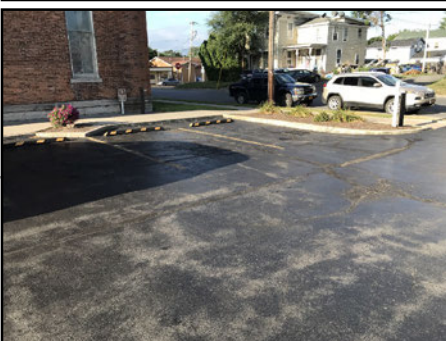
Inspection Date	FMSS Number	User Access	Surface Type
8/18/2020	58822	PUBLIC	ASPHALT
Area (Sq. Ft.)	Lane Miles (11' Widths)	Curb Reveal (Inches)	Curb Recommendation
5,253	0.09	4	LIGHT REPAIR
Curb Type		Curb & Gutter Type	
CONCRETE AND STONE		CONCRETE	
Pavement Recommendation		Condition Rating / PCR	
HEAVY 3R TREATMENTS		POOR / 53

Note: Parking area consists of multiple surface types: 1 part Asphalt at 4,704 square feet; 1 part Concrete at 549 square feet.

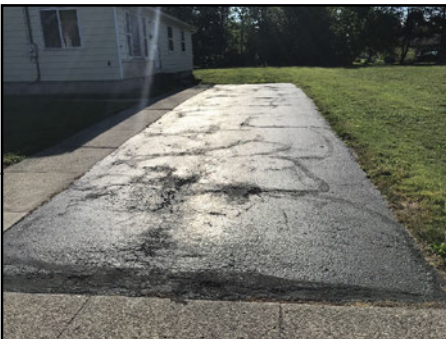
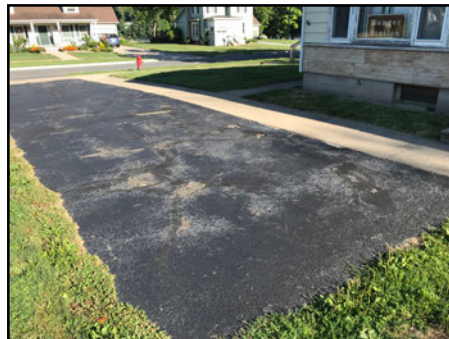
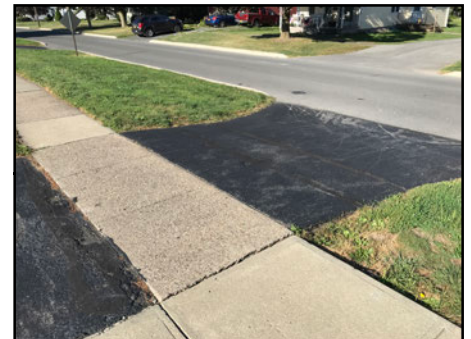
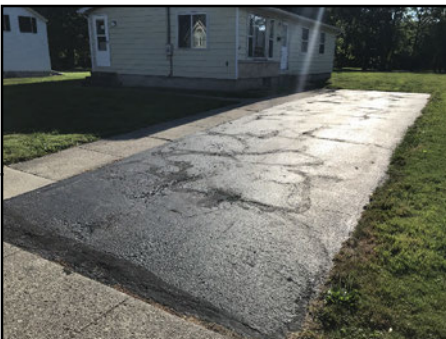
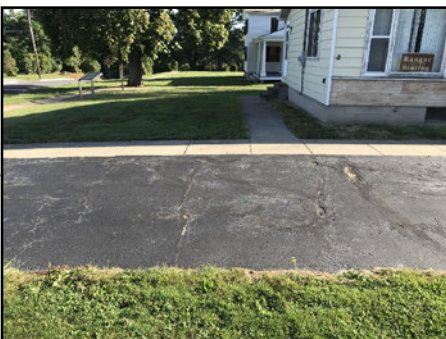
ROUTE 0902: RANGER STATION PARKING

Inspection Date	FMSS Number	User Access	Surface Type
8/18/2020	102912	NONPUBLIC	ASPHALT
Area (Sq. Ft.)	Lane Miles (11' Widths)	Curb Reveal (Inches)	Curb Recommendation
898	0.015	NOT APPLICABLE	NOT APPLICABLE
Curb Type		Curb & Gutter Type	
NO CURB		NO CURB AND GUTTER	
Pavement Recommendation		Condition Rating / PCR	
HEAVY 3R TREATMENTS		POOR / 53

Note: Parking area consists of multiple surface types: 1 part Asphalt at 833 square feet; 1 part Concrete at 65 square feet.

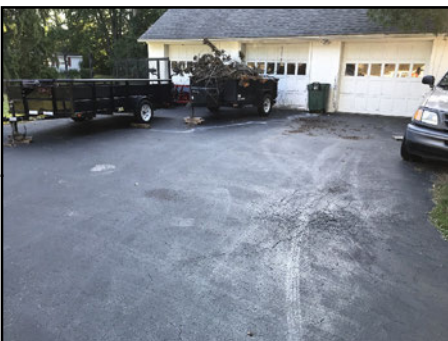
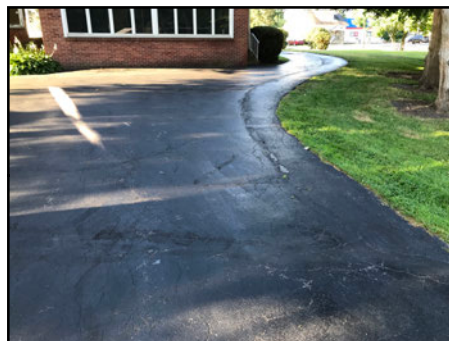
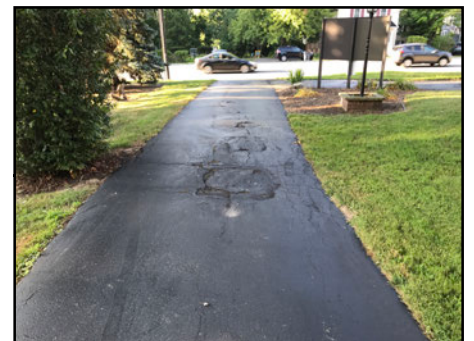
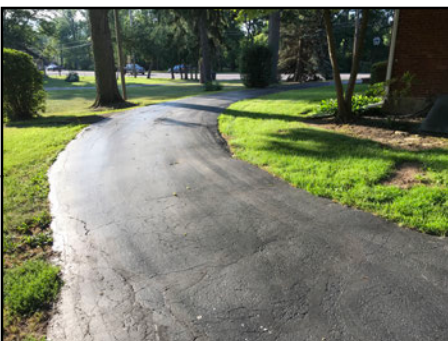
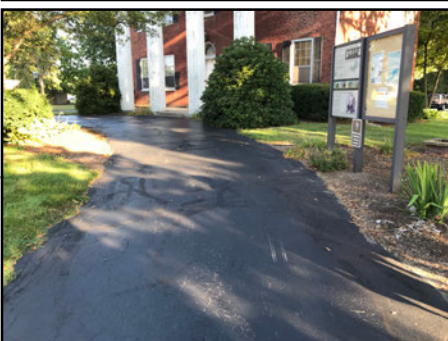
ROUTE 0903: HUNT HOUSE PARKING

Inspection Date	FMSS Number	User Access	Surface Type
8/18/2020	102913	PUBLIC	ASPHALT
Area (Sq. Ft.)	Lane Miles (11' Widths)	Curb Reveal (Inches)	Curb Recommendation
6,107	0.105	NOT APPLICABLE	NOT APPLICABLE
Curb Type		Curb & Gutter Type	
NO CURB		NO CURB AND GUTTER	
Pavement Recommendation		Condition Rating / PCR	
RECONSTRUCTION		POOR / 30
