LIHO Cycle 6

Final Report

Road Inventory and Condition Assessment of Paved Routes Lincoln Home National Historic Site

Report Date: September 2018

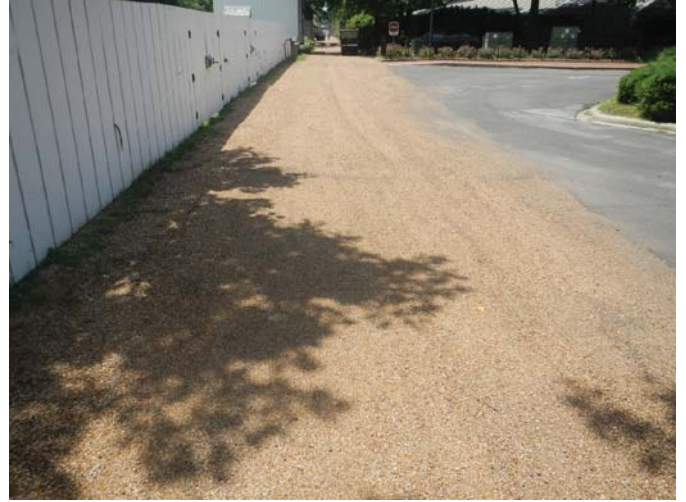
LIHO_0400_3908.JPG

Note: Pavement condition was unable to be assessed due to gravel covering the paved surface.

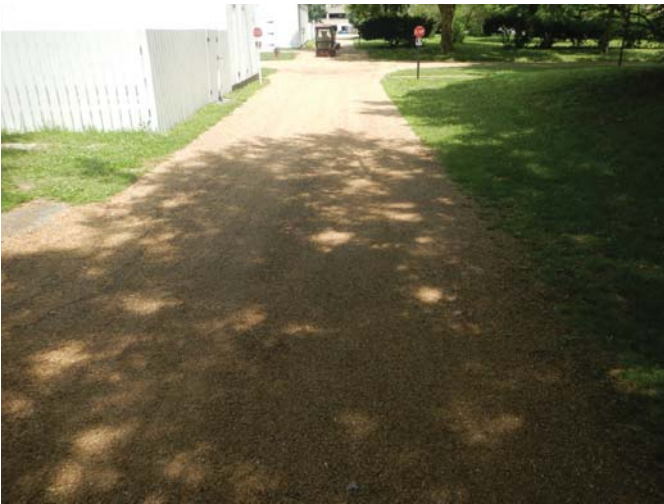
LIHO_0401_3963.JPG

Note: Pavement condition was unable to be assessed due to gravel covering the paved surface.

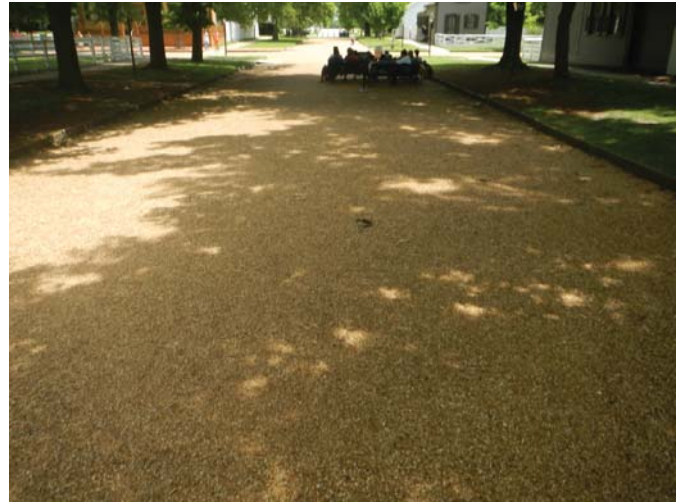
LIHO_0403BZ_3941.JPG

Note: Pavement condition was unable to be assessed due to gravel covering the paved surface.

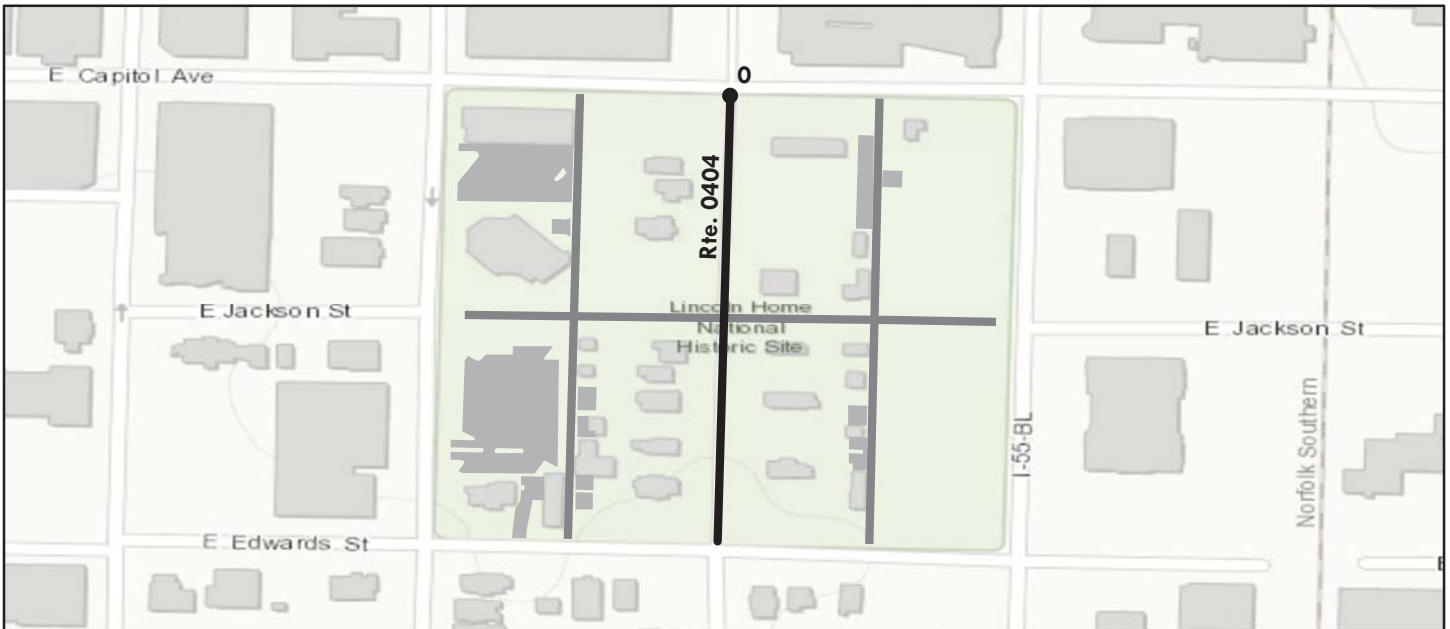
ROUTE 0404: EIGHTH STREET

Note: Pavement condition was unable to be assessed due to gravel covering the paved surface.
